Manhole Inspection Summary

Manhole # S33E__012MH

Location Address: **225 liberty st**

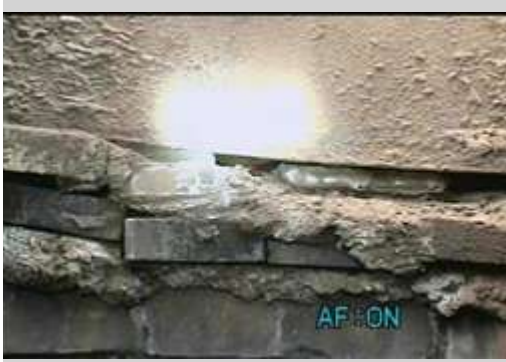
Defect 1

Condition: ☐ Sound ☐ Cracked ☐ Root Intrusion ☒ **Loose Brick** ☒ **Deteriorated**

loose bricks, deteriorated, frame adj
